17 Haslington Street, Leek

DATE WORK CARRIED OUT: August 2007 – July 2008

SUMMARY OF PROJECT: Replacement of Long-Span Sole Plate Beam Carrying Timber Frame

**17 HARTINGTON STREET, LEEK
REPLACEMENT OF UPPER TIMBER FRAME SOLE PLATE BEAM
(JOB REF: 31654)**

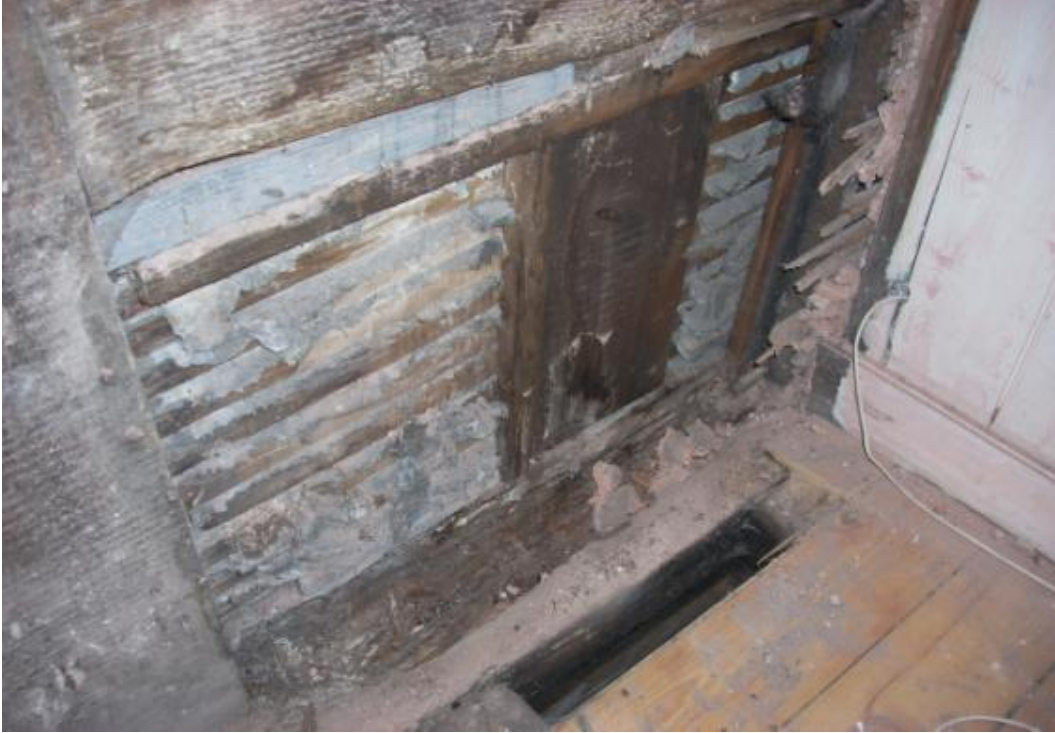
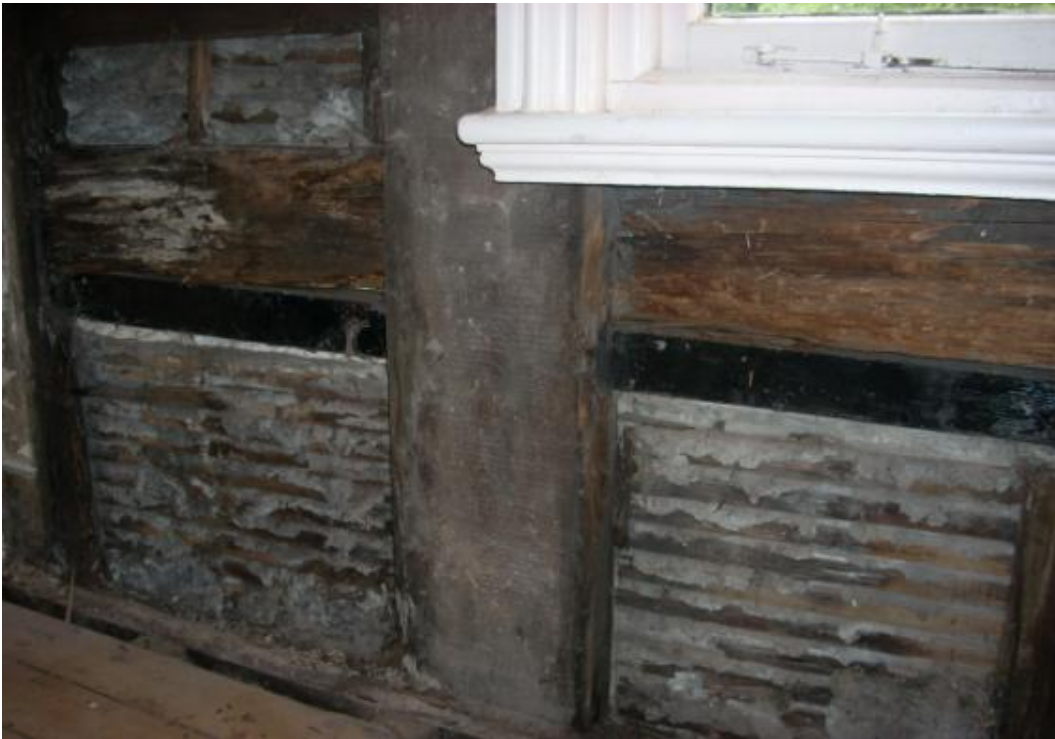
Close examination of the exposed soleplate beam revealed that it had clearly suffered from ingress of water causing wet rot over a long period of time and that substantial part of the core (up to 70% of section) of the large oak beam had in places been lost or compromised through decay.

Our survey found the exposed bottom sole plate beam to be severely rotten due to past water ingress. Using knowledge gained from carrying out property surveys over a twenty five year professional career it was clear that the extent of the decay in the heartwood meant that an economic repair insitu was not a realistic option and complete replacement of the member was the only practical alternative.

PART EXPOSURE OF UPPER TIMBER FRAME AND SOLE PLATE BEAM

A recommendation for like-for-like beam replacement rather than patch repair was also made in light of the intricacies of reforming traditional mortise - tenon and pegged construction that would remain in plain view and the unknowns that could be affecting other parts and elements in the timber frame.

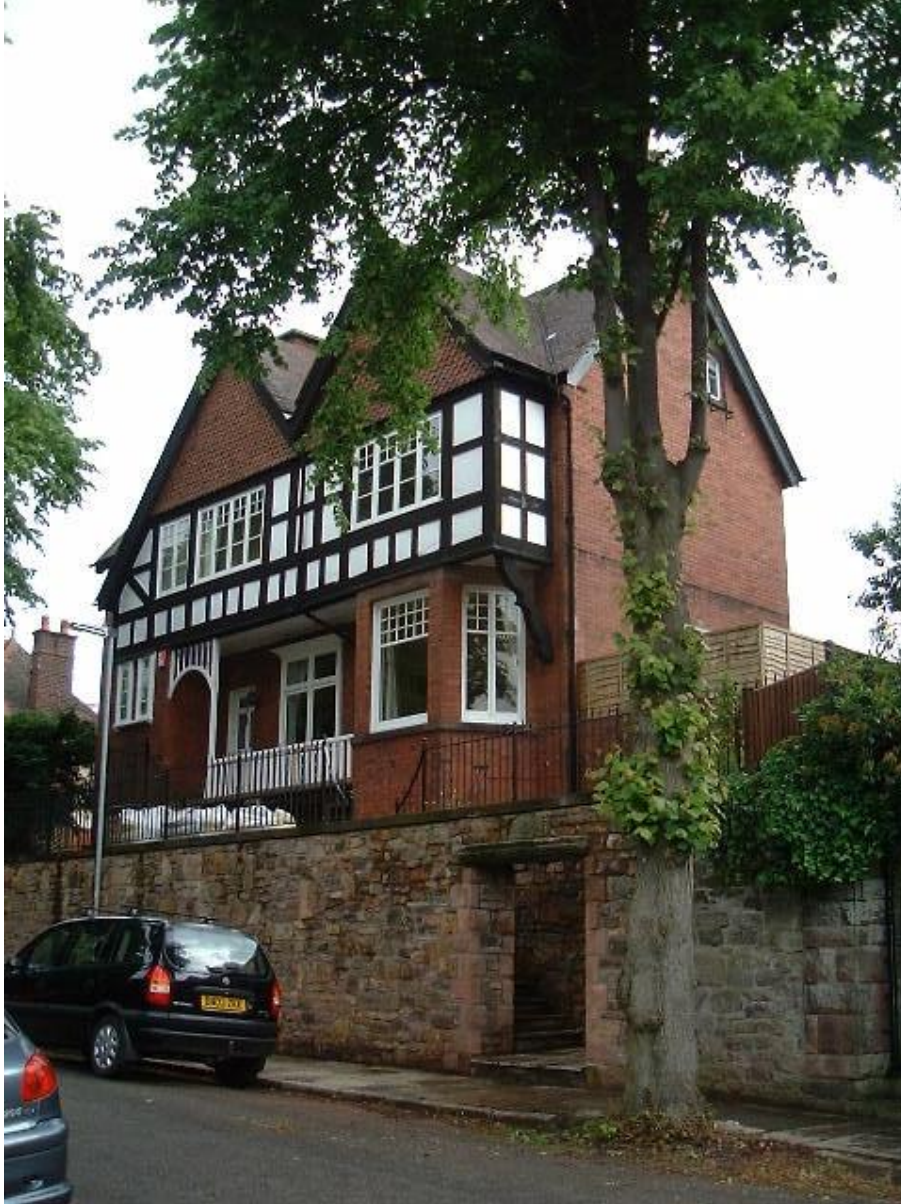
FRONT CORNER ELEVATION PRIOR TO WORKS

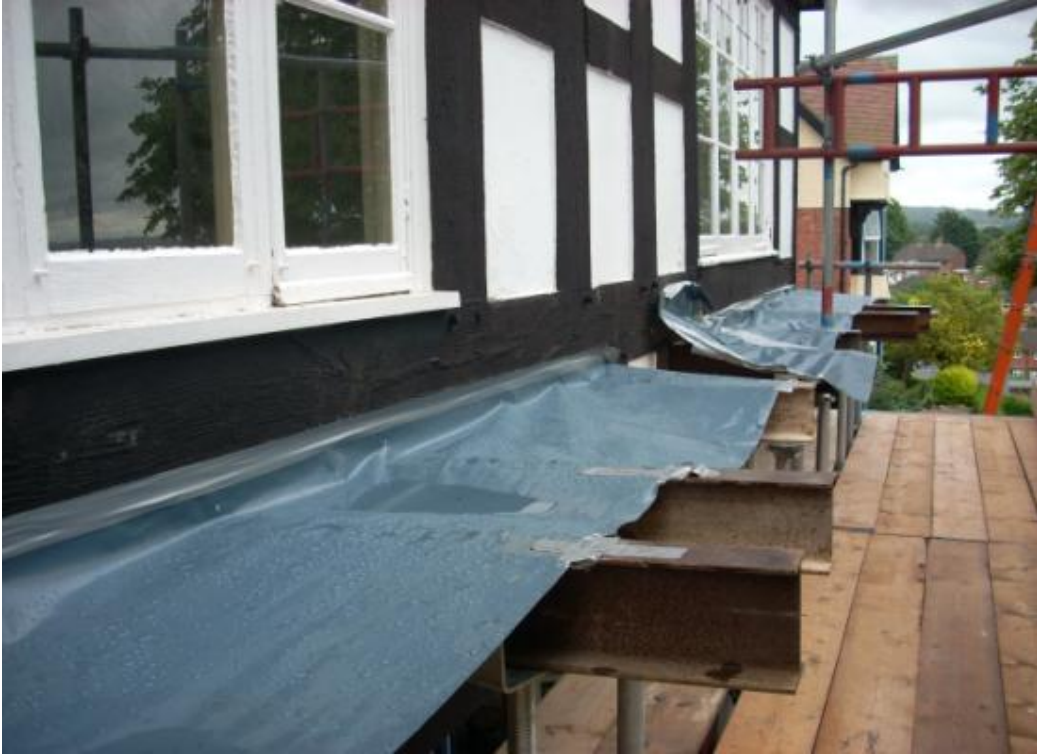
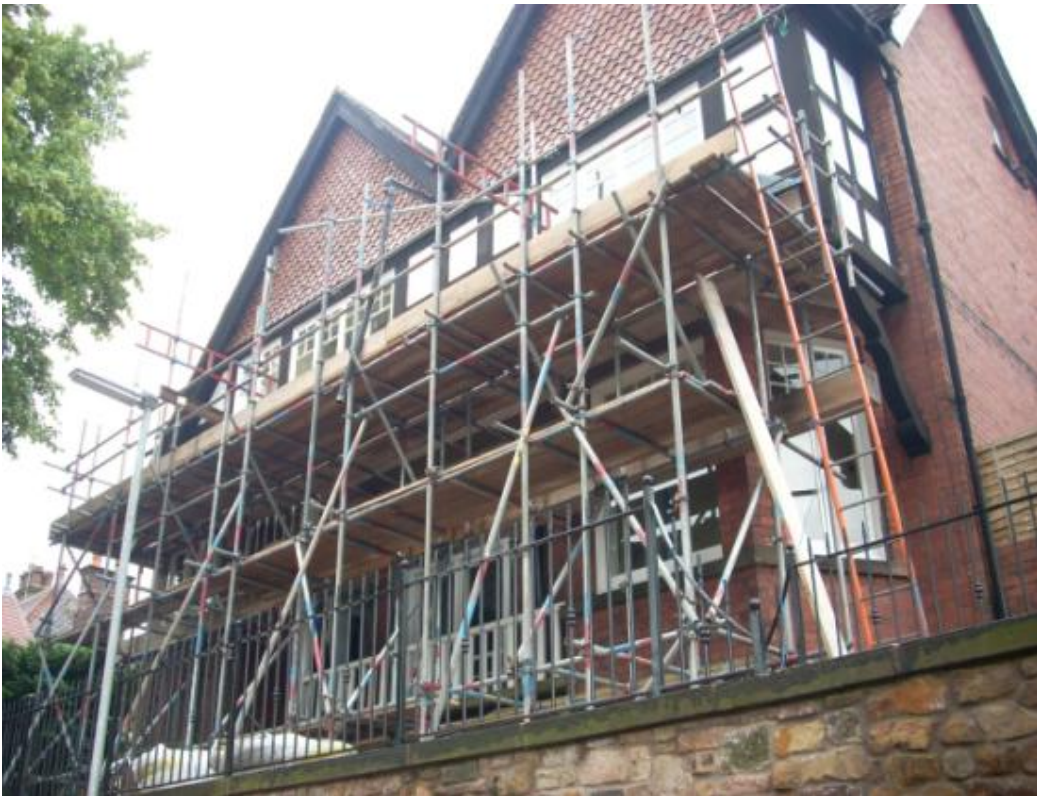
TEMPORARY SUPPORT SCAFFOLD – WORKS IN PROGRESS

Our final role was to inspect the method of needle support and pinning up provided by the Contractor to ensure that the critical points of load were well supported in the temporary situation and that steel splice plates were provided on the face of the frame across any of the connections where the strength and integrity of the joint was uncertain or suspect. Finally small drips and flashings were to be introduced on completion to the bottom side of infill rendered panel sections to dissuade rainwater ingress especially at the joints
