17 Haslington Street, Leek

DATE WORK CARRIED OUT: August 2007 – July 2008

SUMMARY OF PROJECT: Replacement of Long-Span Sole Plate Beam Carrying Timber Frame

**17 HARTINGTON STREET, LEEK
REPLACEMENT OF UPPER TIMBER FRAME SOLE PLATE BEAM
(JOB REF: 31654)**

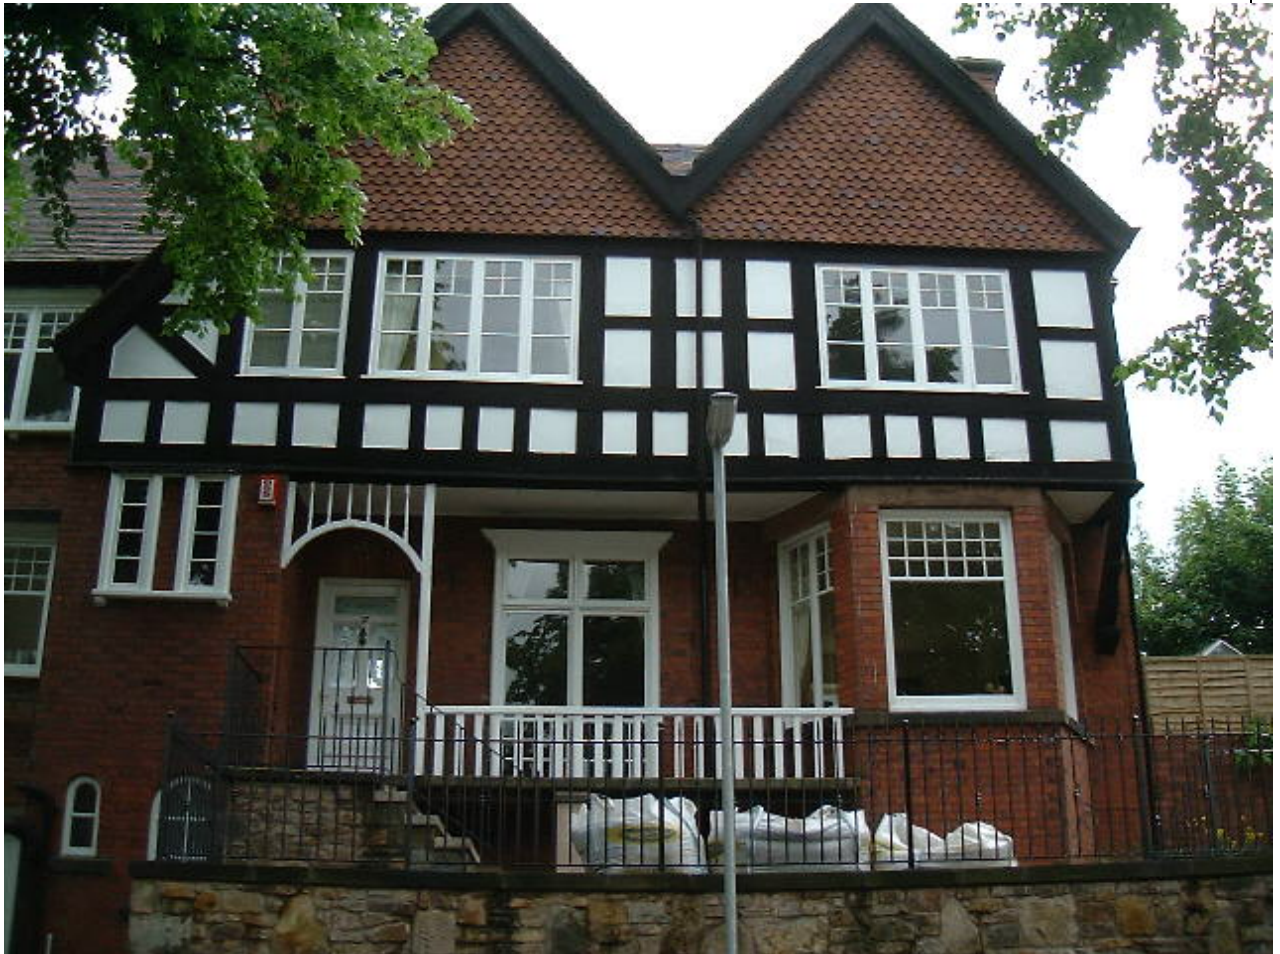
REMEDIAL WORK IS REQUIRED TO THE FRONT FACADE TIMBER FRAME AT FIRST FLOOR LEVEL WHICH HAS BEEN AFFECTED BY ROT.

WE UNDERSTAND THAT THE EXISTING DEFECTIVE TIMBER SOLE PLATE IS TO BE REMOVED AND REPLACED WITH AN EQUIVALENT SIZE NEW TIMBER. IN ORDER TO EXTRACT THIS MEMBER IT IS NECESSARY TO TEMPORARILY SUPPORT THE EXISTING FRONT WALL FRAME ABOVE FIRST FLOOR LEVEL AND TO ALSO SUPPORT THE FIRST FLOOR CONSTRUCTION ALONG THE BAY SECTION.
